WATER TREATMENT

Dewatering oily wastewater

CASE STUDY TAG 40A60

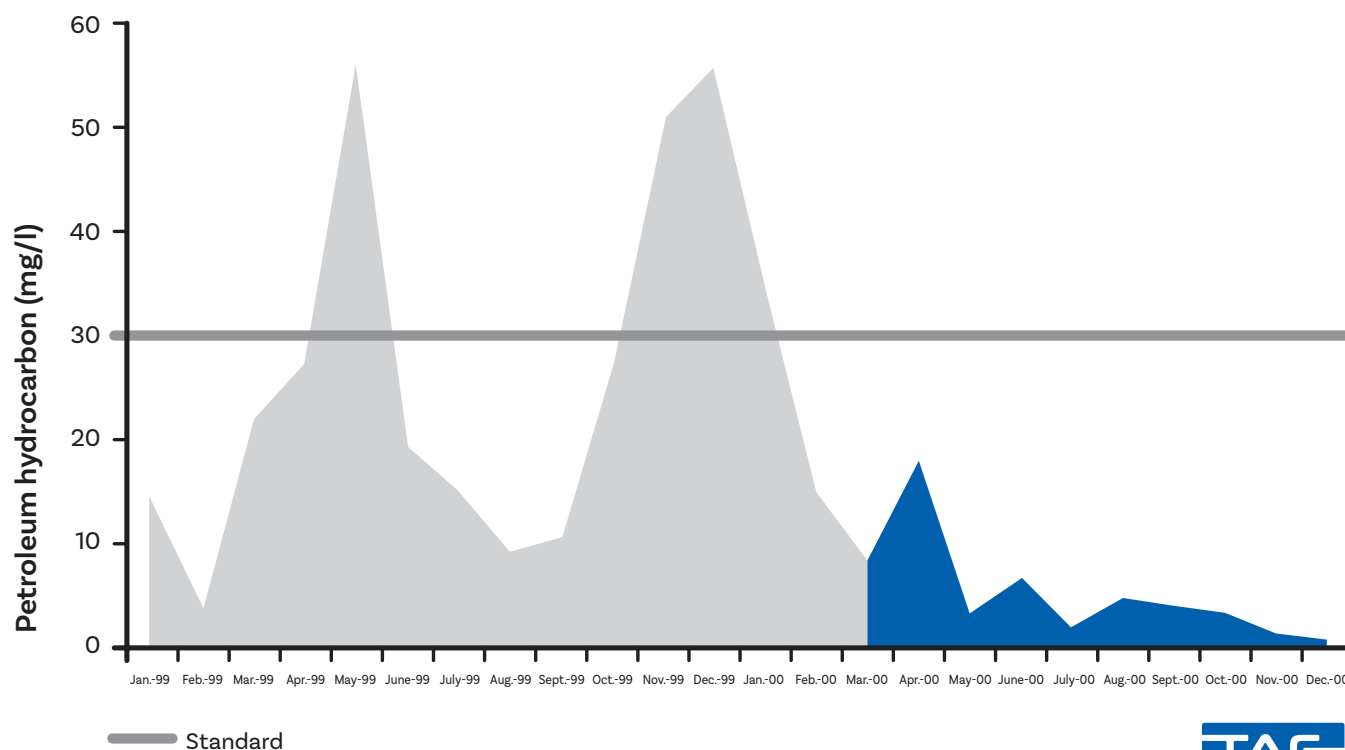
MONTHLY PETROLEUM HYDROCARBON RESULTS CURVE

The clarified water was still cloudy, so there was oil in the water. Often the oil concentration was slightly below the standard and over a period of 13 months, the four-month results far exceeded the standard.

After 12 months of use, the oil and grease residue still met the standard. Visually, the clarified water was clear. The breeding of microflora was eliminated.

When TAG 40A60 was used, industrial oily wastewater discharge standards were maintained at all times. The decreased sludge volume slightly reduced the cost of sludge disposal.

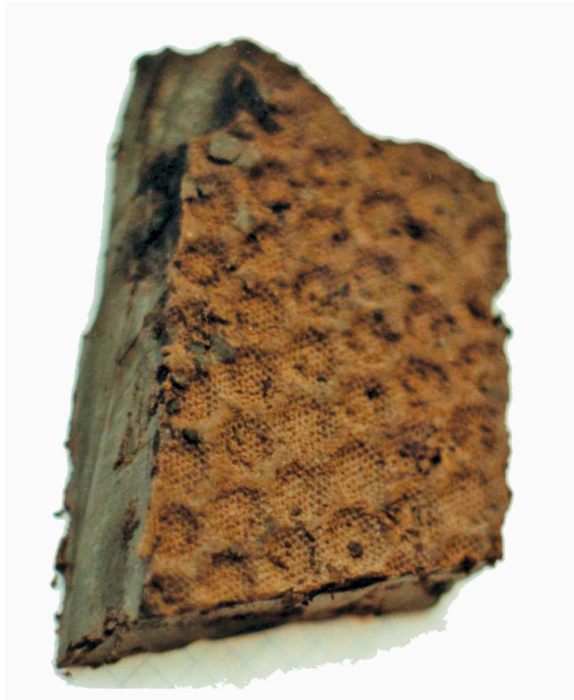
PHOTO 1

Shows the quality of the oily water dewatering. Note that the cake was cut with a knife, because its consistency was similar to shoe polish.

The solidity of oily sludge was very high, at 31% dryness. Once the cake was removed from the press, 10 psi of pressure was applied to a sample. A slight mark was made on the surface of the block. These parameters demonstrate that the cake was well dewatered and could be easily removed from the filter press.

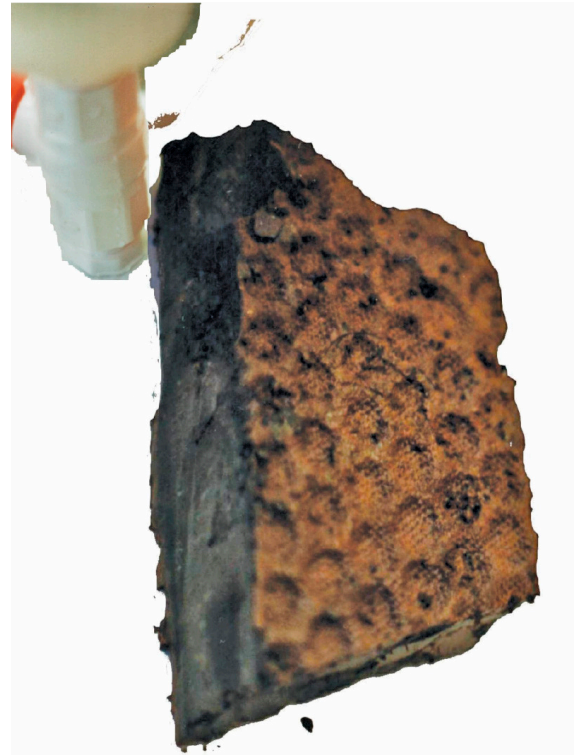
PHOTO 2

Shows the same sample as Photo 1 after being subjected to 10 psi of pressure for five minutes.
